# PRODUCT BULLETIN

In a continuing effort to offer the most updated and innovative products to the market, and remain the industry leader in corrosion preventative measures, Vanguard National Trailer is proud to announce we have redesigned an upgrade to the rear of our standard trailer floor which incorporates a completely galvanized "Unitized Forklift Package" or UFP for short. In addition to the UFP upgrade, Vanguard is offering various configurations of the bumper/under ride area. Attached is a PDF drawing featuring the newest upgrade to the Vanguard Trailer, the Unitized Forklift Package, and a PDF featuring the standard bumper/under ride configuration in addition to the 12 optional variations. Pricing for each of these bumper/under ride variations will be available shortly. If there are any questions, please contact the Vanguard Sales Department for more details.

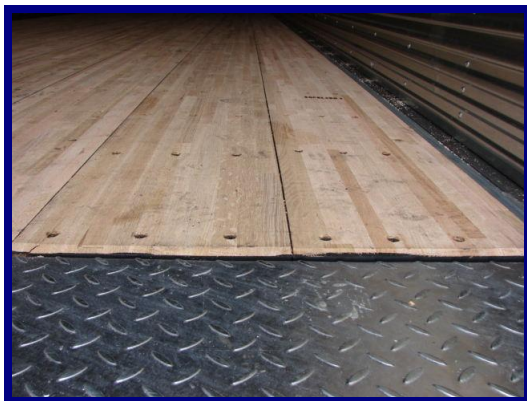
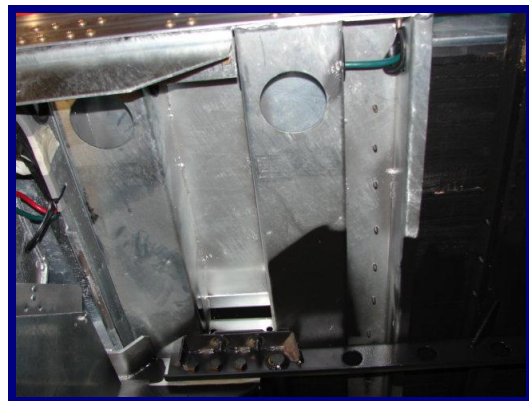
1. (4) 4" I-beam crossmembers are replaced by the new 5-1/4" tall galvanized steel assembly.
2. The current (4) crossmembers have a web thickness of .092" @ 80 KSI. The web thickness for the (5) UFP supports is .138" @ 66.7 KSI each, resulting in a crossmember relative web strength of 7,360 verses a UFP relative web strength of 9,205, or 20% more strength.

3. There are (16) intercostals deck reinforcing angles for forklift tire load protection, which protects against floor damage and "dishing".
4. New standard galvanized threshold is 3/16" thick and 24" vs. the current galvanized 22" threshold for additional forklift damage protection.

5. The UFP assembly provides strength and support above the slide rail where the RIG adapter is located and attached to the rear impact guard which exceeds previous rear bumper/under ride protection.

6. There is no wood flooring under the rear threshold plate to eliminate the most common area for floor rot leading to failures.
7. The upgrade to the UFP provides 13 separate bumper configurations. (See attached PDF file.)
